TECHNICAL REPORT RL-76-13

2.75-INCH ROCKET LAUNCHER ICE PROTECTION  
TESTS, DECEMBER 1975 TO FEBRUARY 1976

Donald Davis  
Ground Equipment and Materials Directorate  
US Army Missile Research, Development and Engineering Laboratory  
US Army Missile Command  
Redstone Arsenal, Alabama 35809

18 March 1976

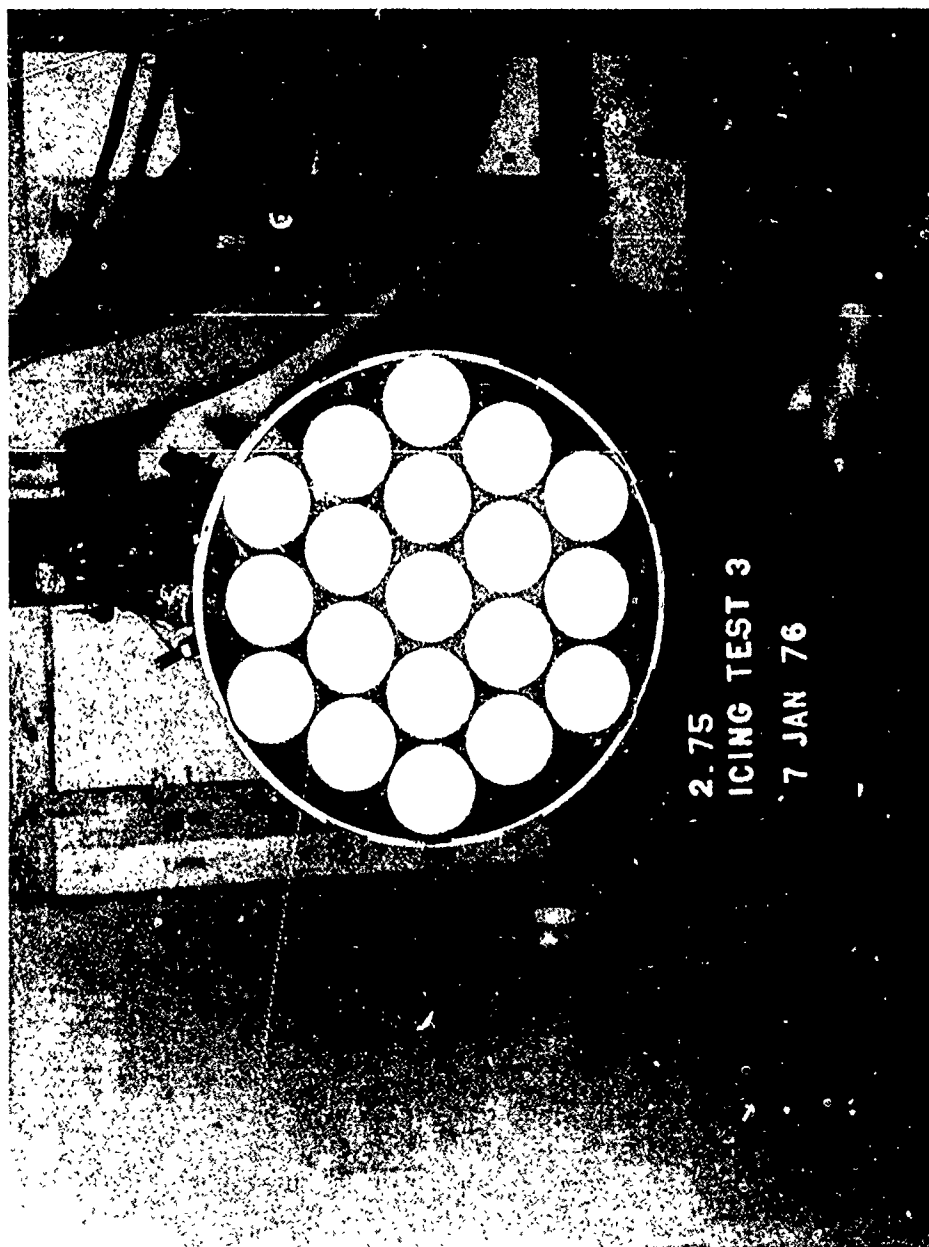
Figure 7. Etha-foam plugs installed.

For test 3, six rockets with M151 (10 pounds) inert warheads were loaded into an M200 launcher with the plugs installed (Figure 7). After applying 1/2 inch of ice to the front of the launcher, all the rockets were successfully fired and flew normal trajectories.

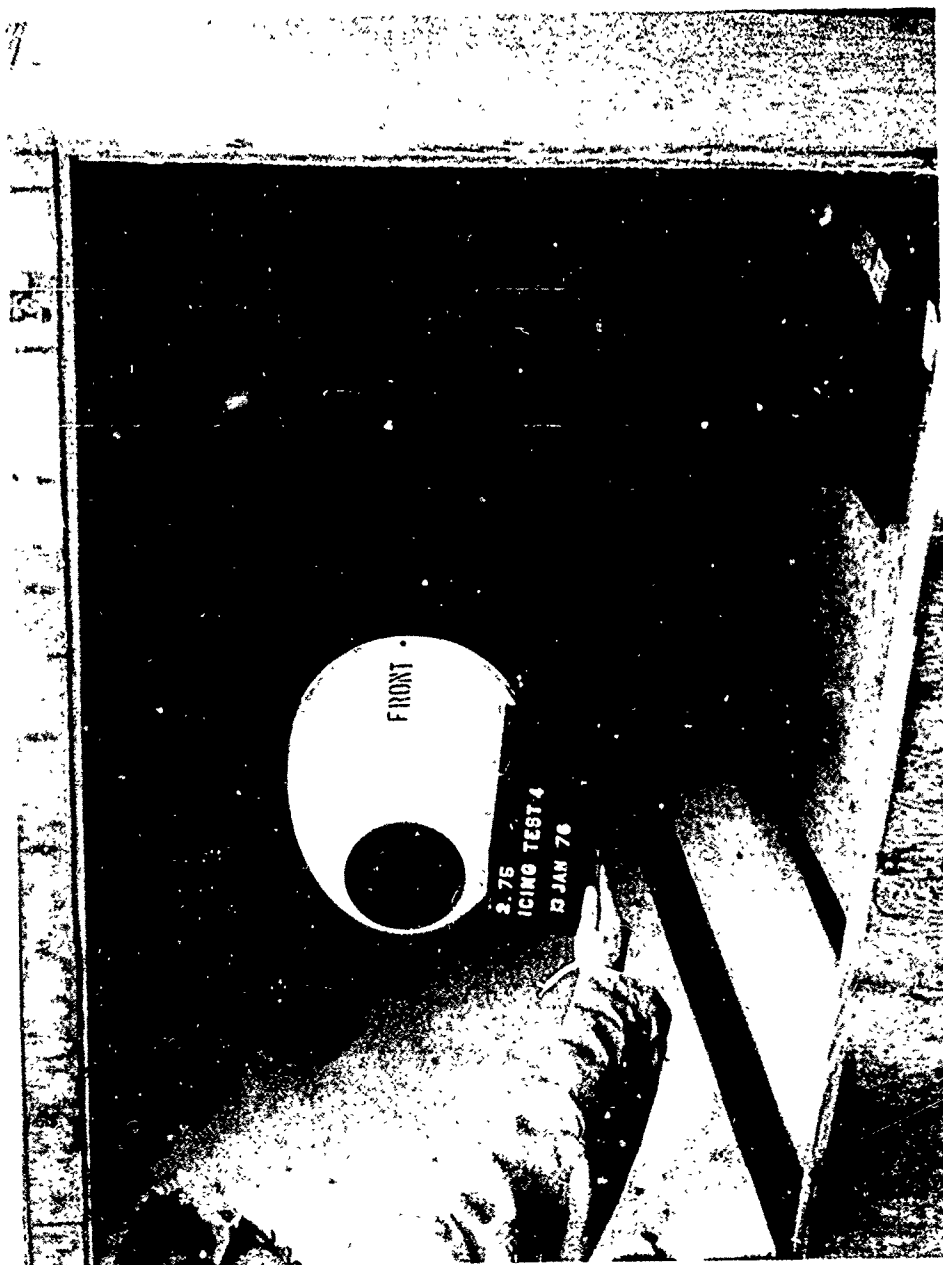
Figure 12. LAU 61A/A fairing.

The fairing presents two problems. As with the dust cover, the protection is removed with the early rockets from the pod, thus leaving the launcher vulnerable to later icing. The fairing itself produces large pieces of debris. Discussions with pilots indicate that the size of the fragments is unacceptable (Figure 13).

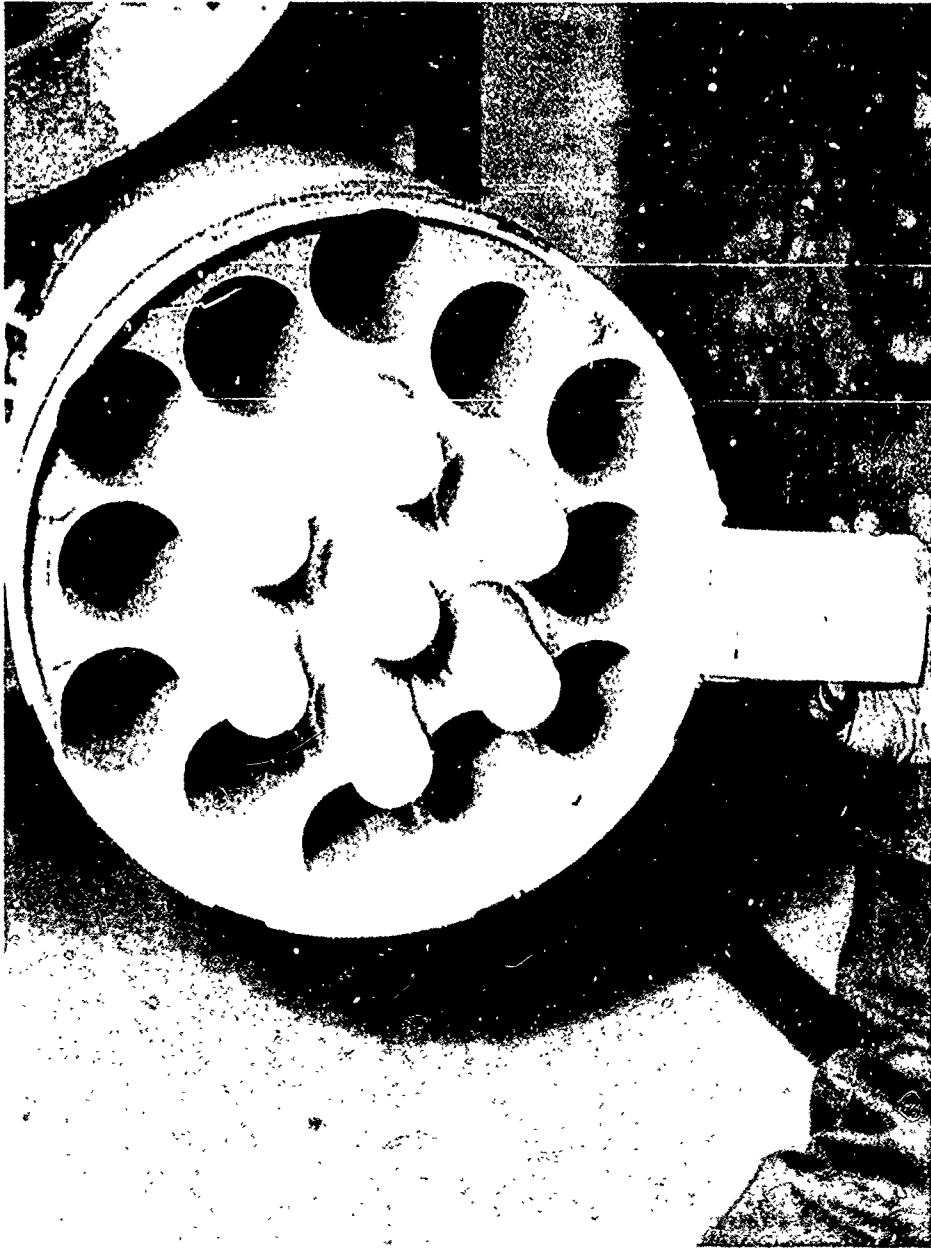
Figure 14. Ring plugs installed with 17-pound warheads.

All previous tests had been conducted with M151 warheads (i.e., 10-pound warheads). The M229, or 17-pound warhead, is longer than the M151 and protrudes beyond the end of all current launchers. To keep water and ice out of the launch tube, a seal around the warhead is required. This seal, or "plug," was a strip of Etha-foam that wrapped around the warhead near the launcher bulkhead. Dimensions for the strip were: length - 3.8 inches; thickness - 0.30 to 0.35 inch; a taper cut across the width - 9 to 10°. This angle matches the taper of the warhead where it passes through the bulkhead. The plugs are flush with the bulkhead when installed (Figure 14).

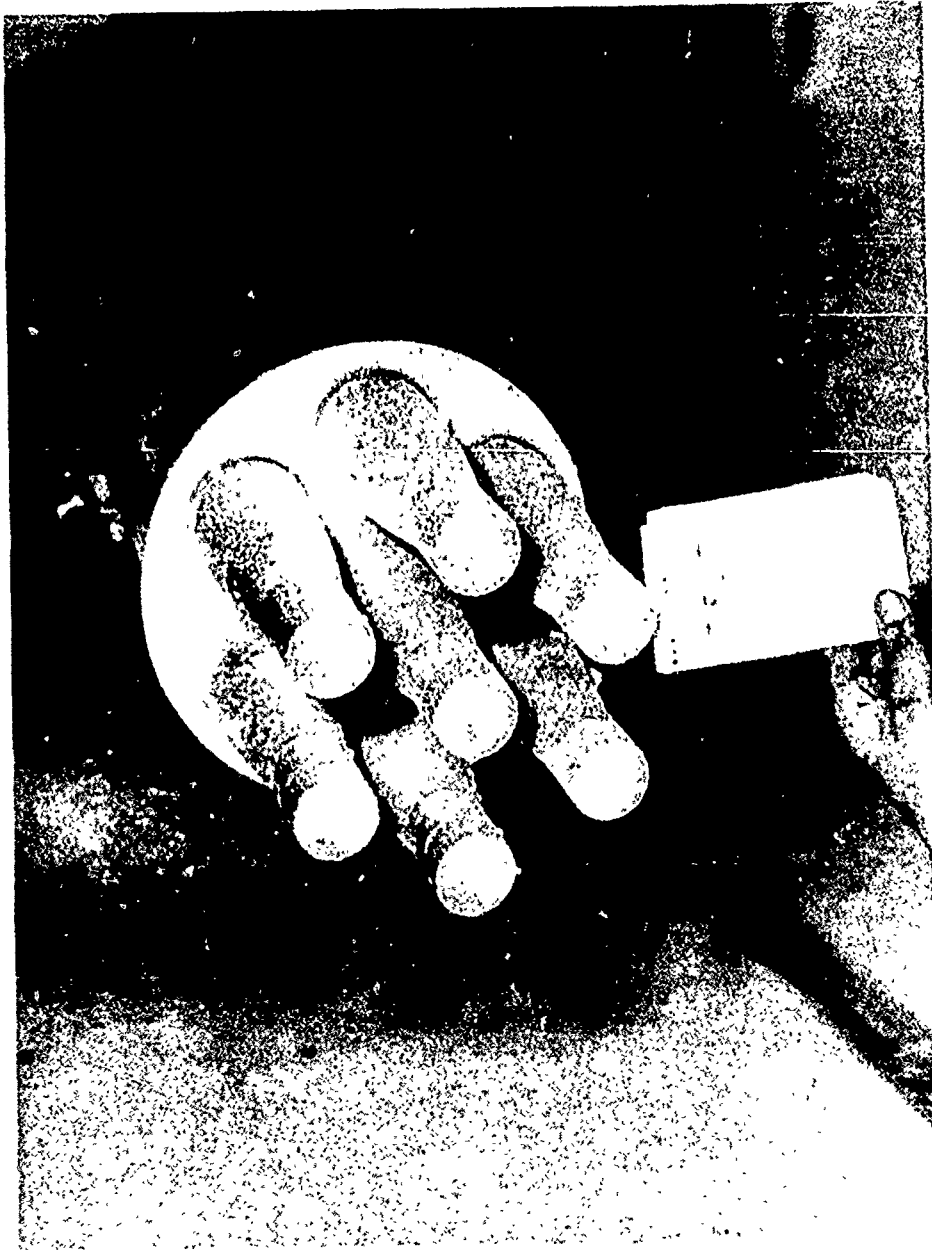
Figure 17. Long warhead simulation with O-rings.

Tube No. 1 was loaded with a live rocket and a M229 warhead. Tube No. 2 is an outside tube. The other six tubes were loaded with inert rockets and warheads (Figure 17) and more than 1/2 inch of ice was applied (Figure 18). There was no evidence of runback inside the tubes.

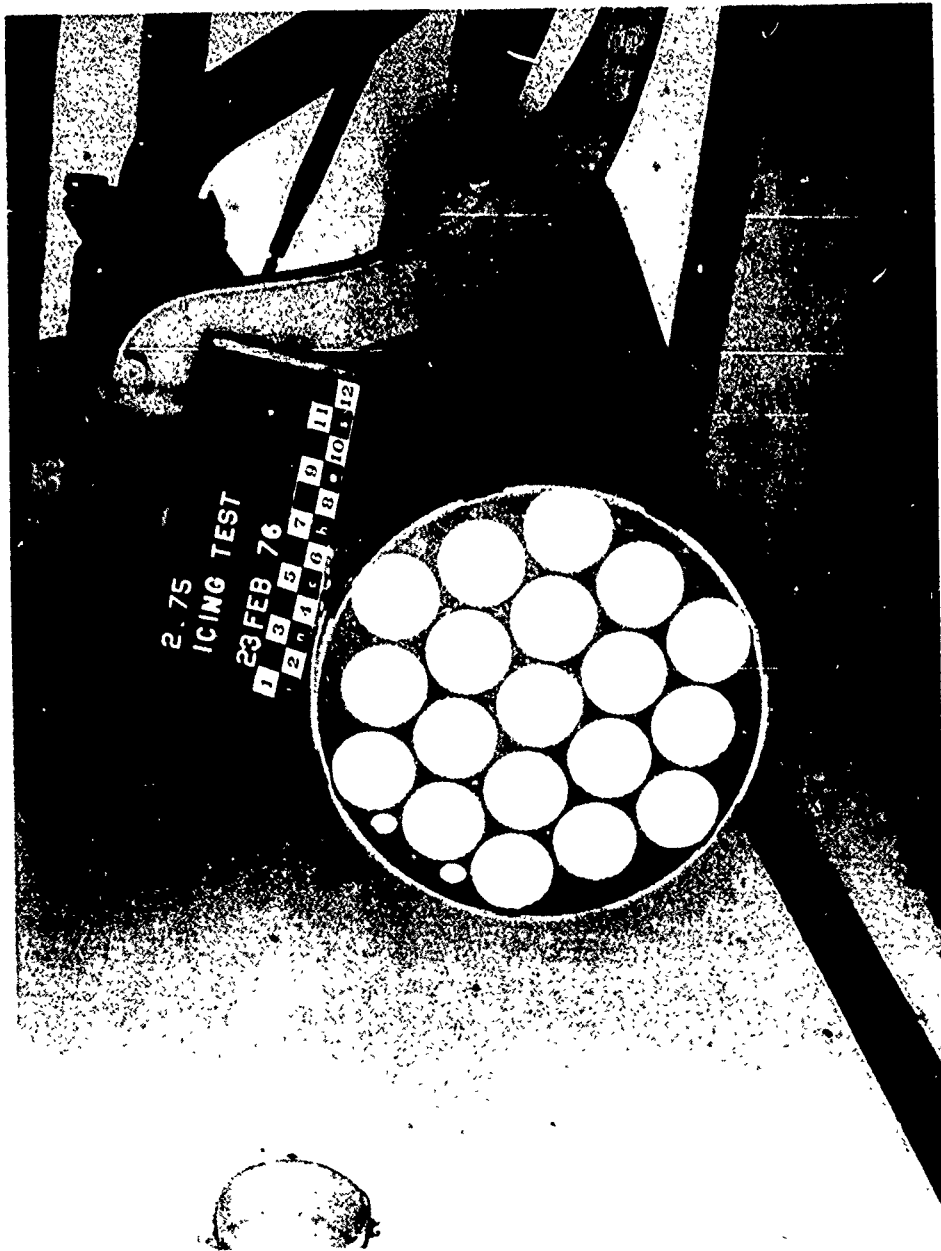
Figure 20. Heater bulkhead installed.

For the final test in this series, the masonite/styrofoam combination was installed on the M200 (Figure 20). One-half inch of ice was applied. Three rockets were loaded and fired.
